RFP for Public Art at Wade Municipal Stadium

Steel Gates along Third Baseline Wall

PHASE 2: MASONRY RESTORATION

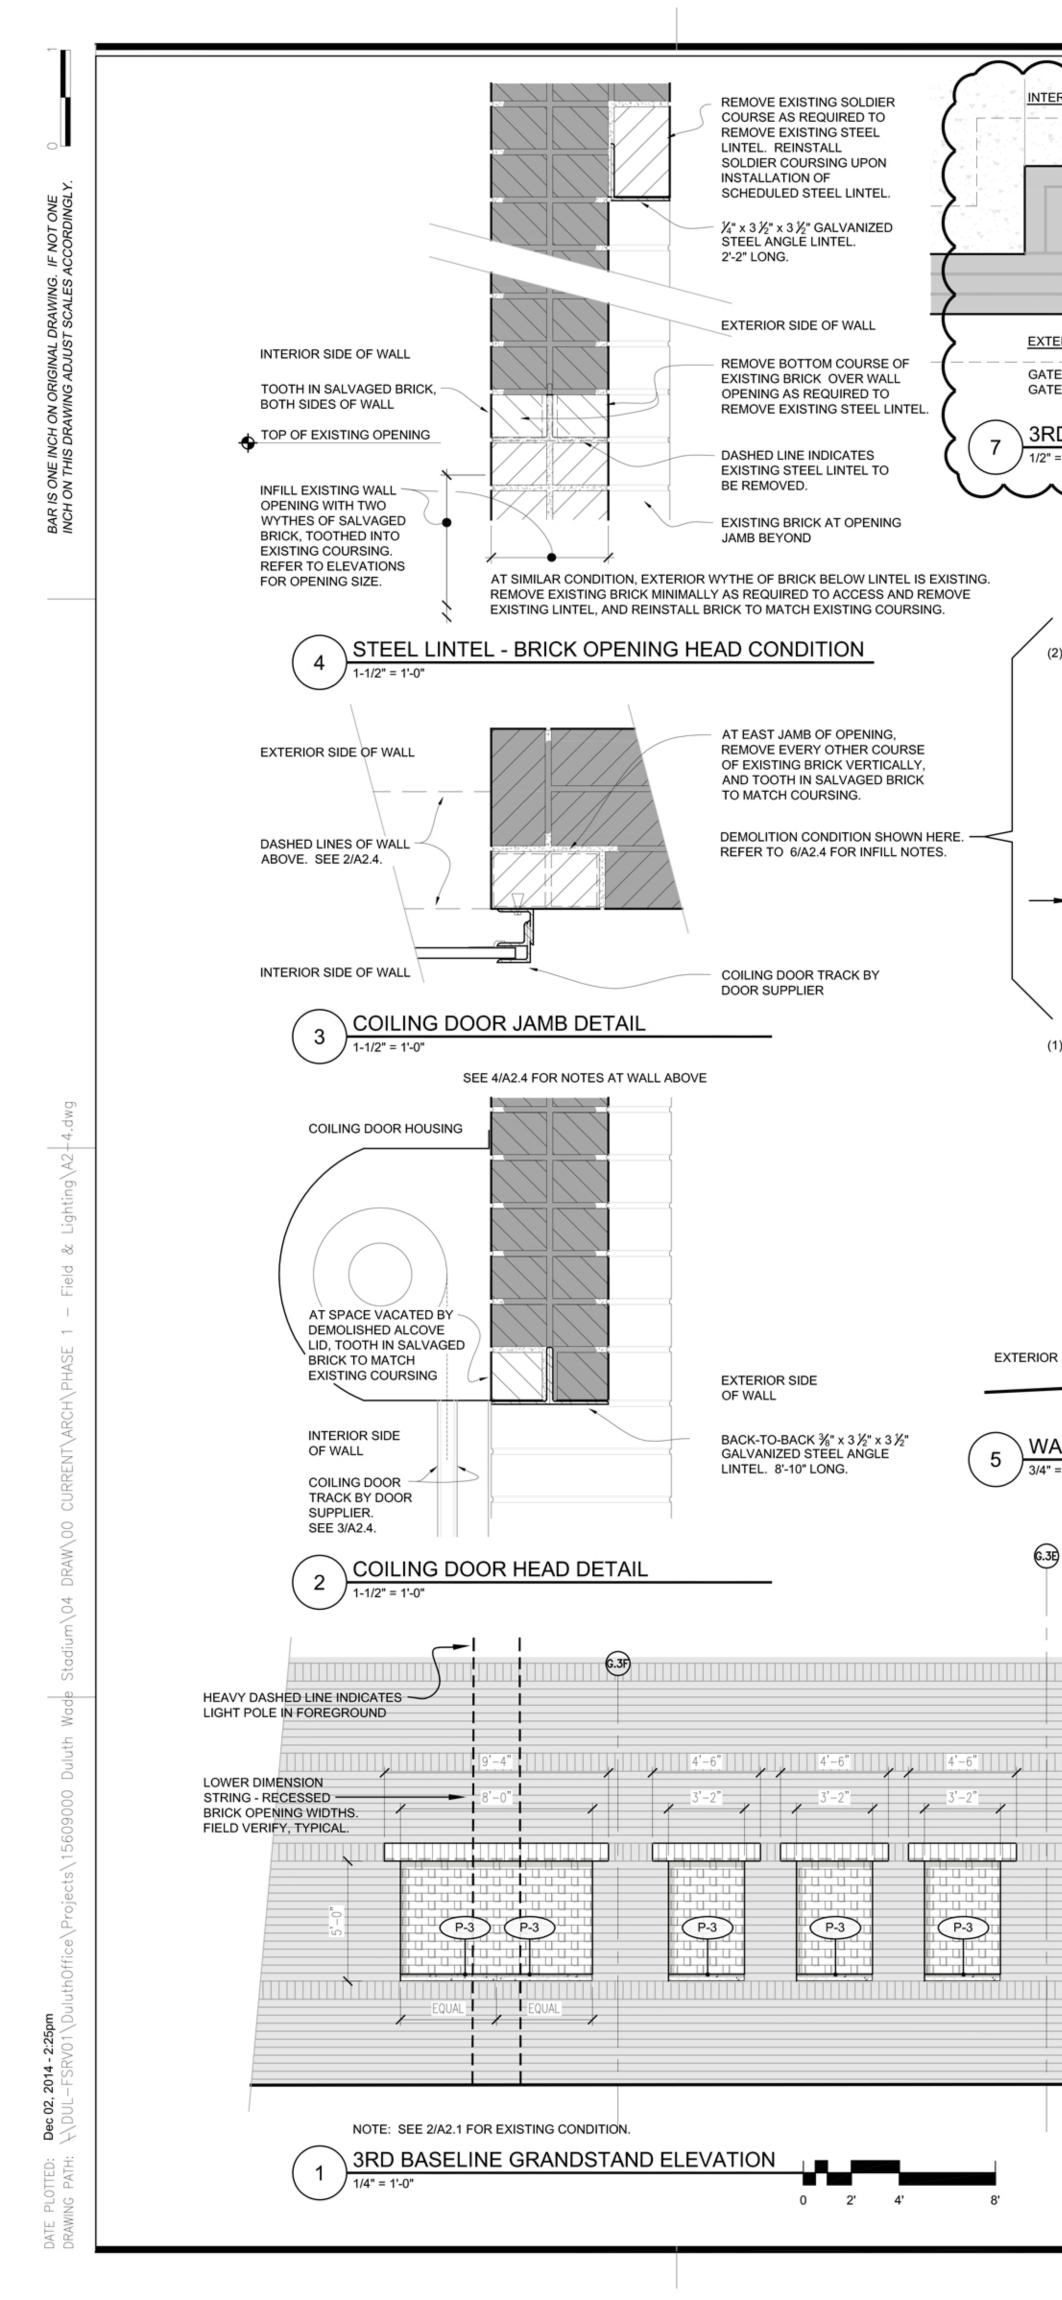
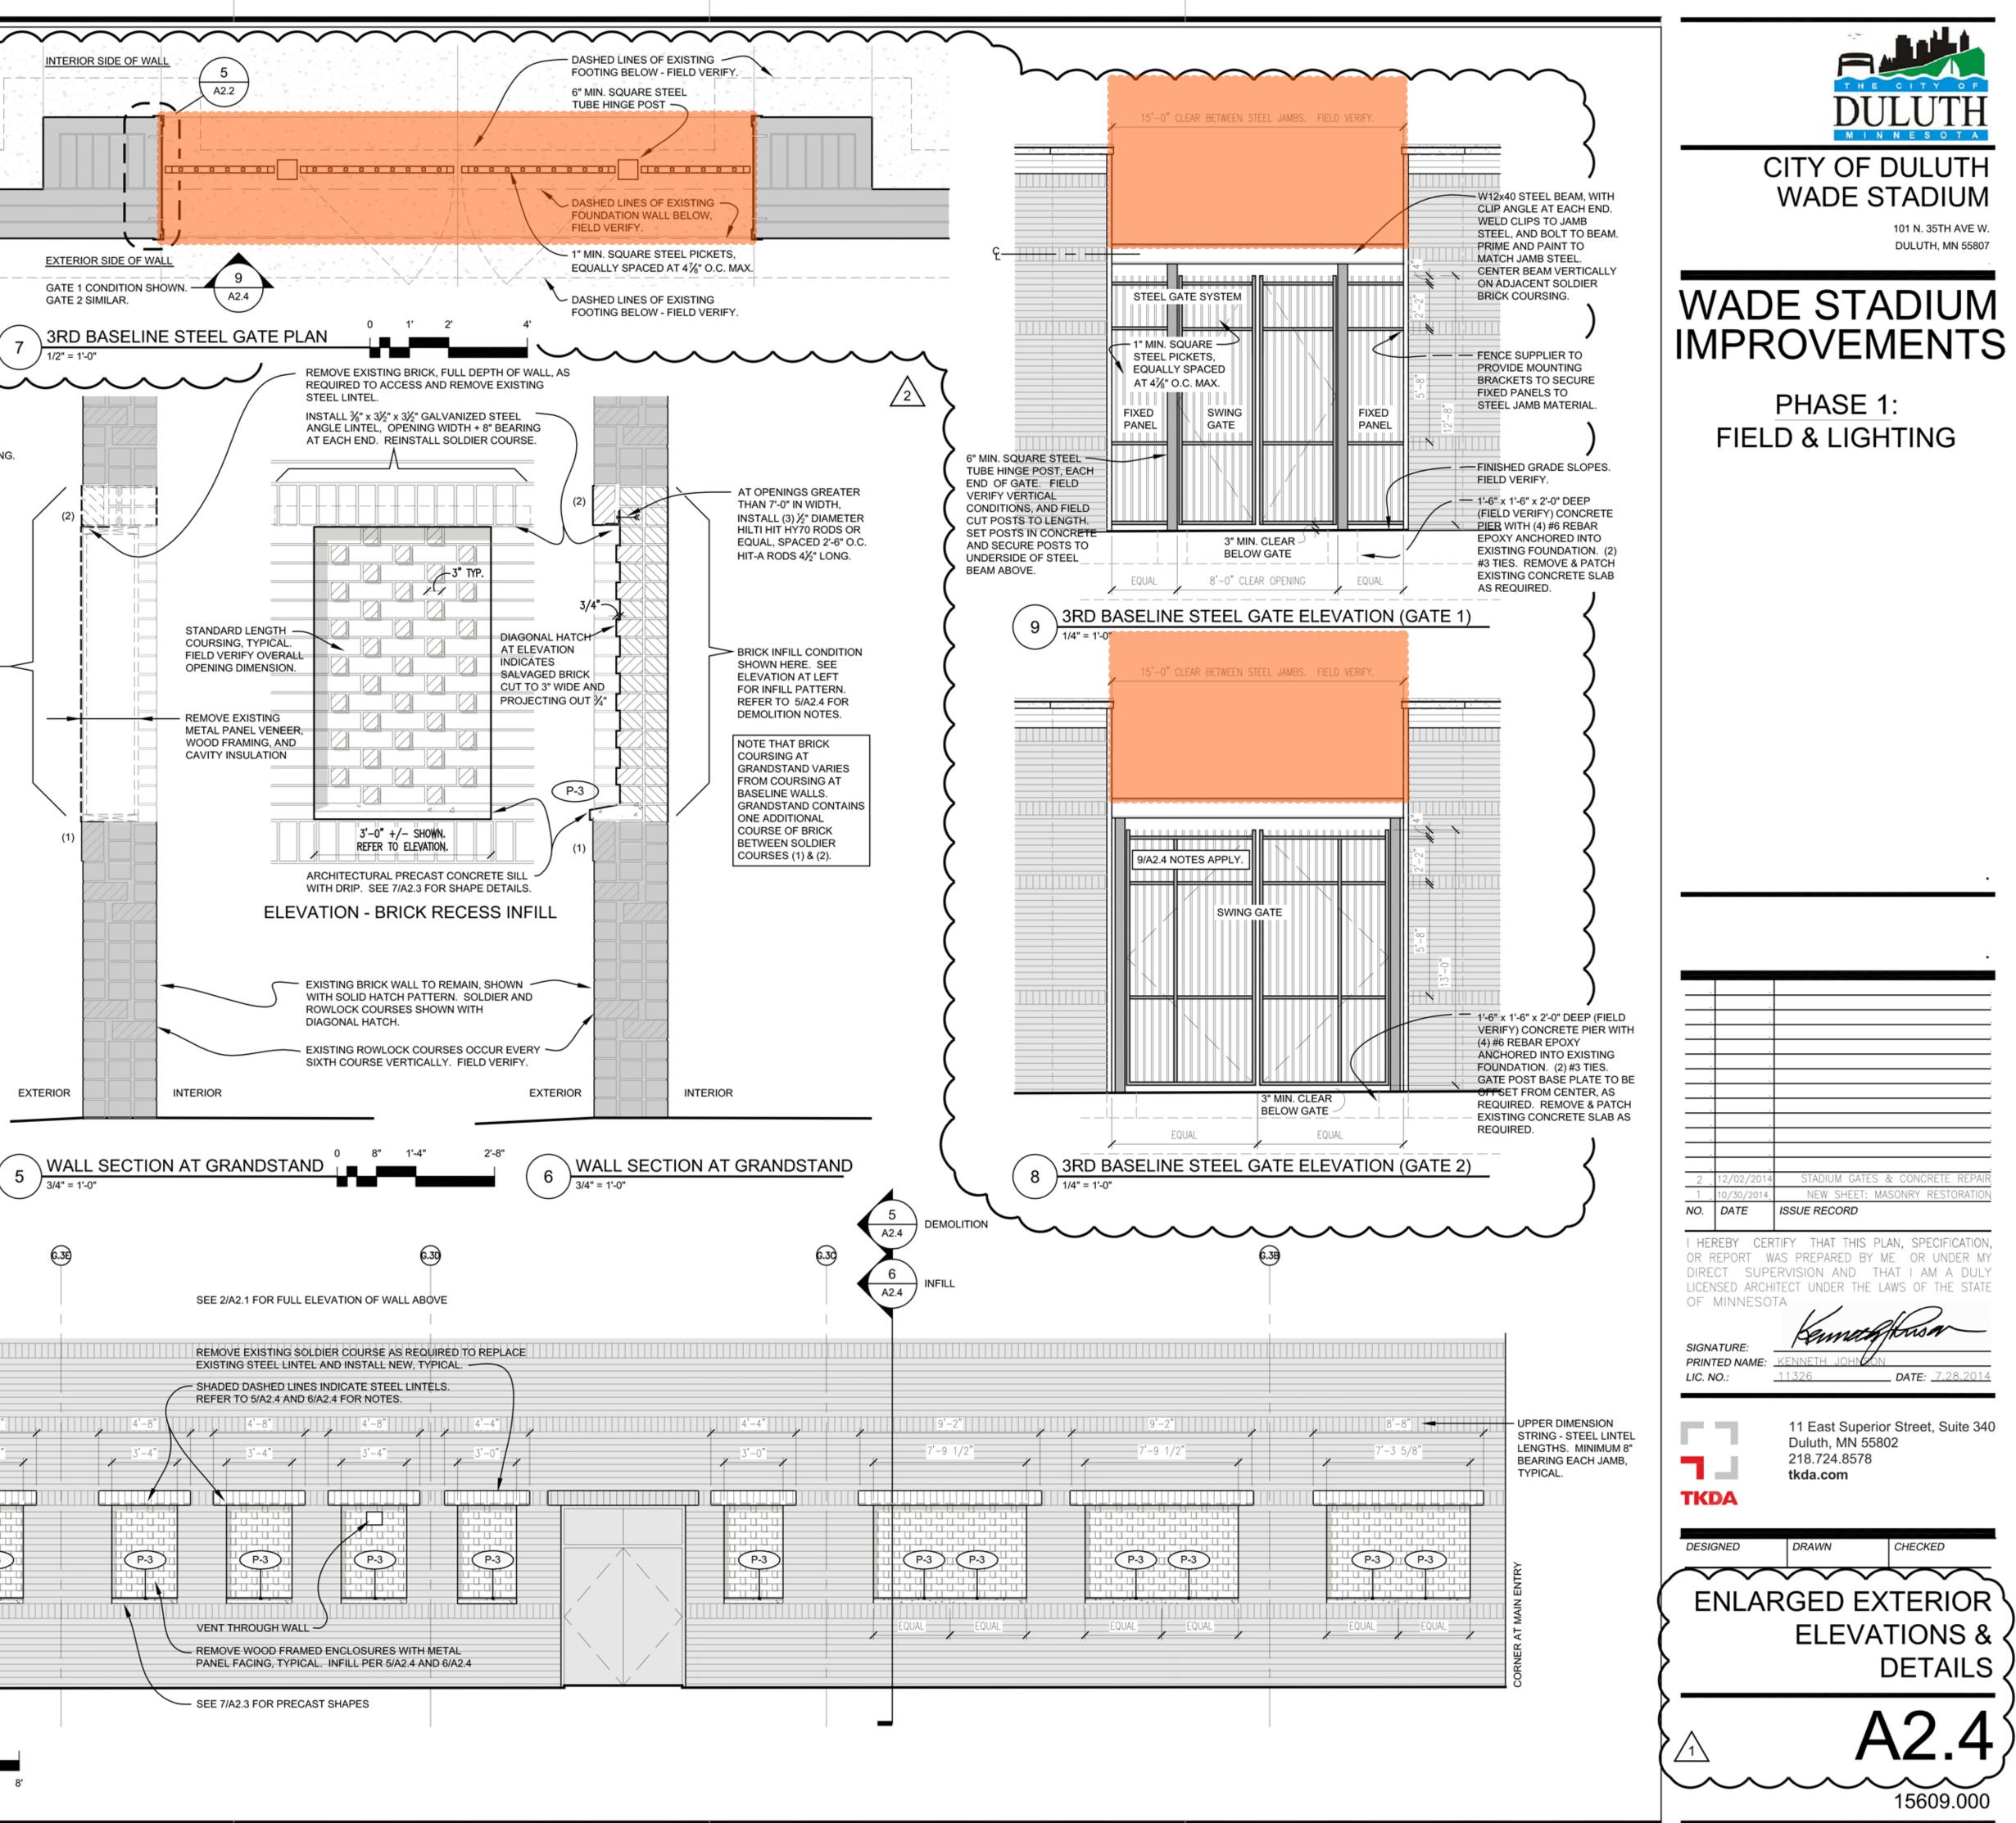
INTERIOR SIDE OF WALL

EXTERIOR SIDE OF WALL

GATE 2 SIMILAR.
